FATIGUE BEHAVIOR OF Ti-8Al-1Mo-1V SHEET
IN A SIMULATED WING STRUCTURE UNDER
THE ENVIRONMENT OF A SUPERSONIC TRANSPORT

by John J. Peterson

Prepared under Contract No. NAS 1-2998 by
LTV VOUGHT AERONAUTICS
Dallas, Texas
for Langley Research Center

NATIONAL AERONAUTICS AND SPACE ADMINISTRATION • WASHINGTON, D. C. • NOVEMBER 1965

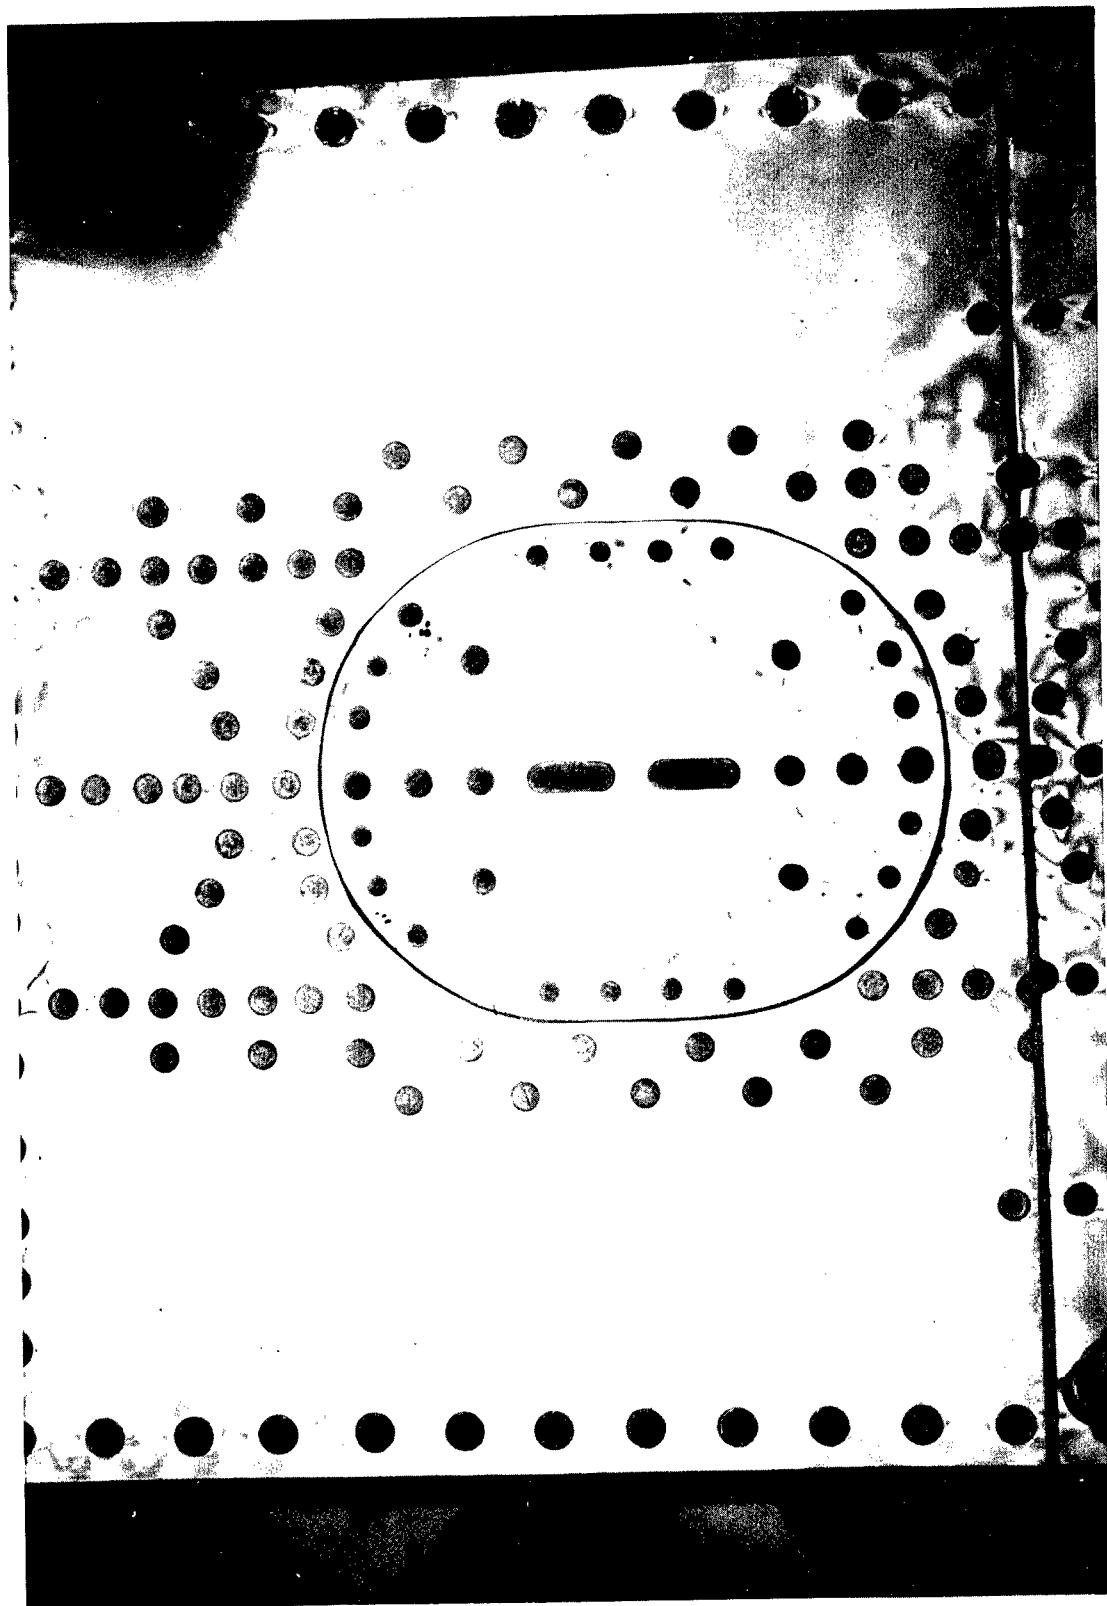
Summary of Results. - Figures 11, 12, and 13 are photographs showing isochromatics observed in the critical areas of the test section. Figure 14 shows measured stress levels at various locations within the test section at an applied load of 20 000 lbs. Figure 15 shows the location of strain gages within the test section while observed strain values at the incremental load points are shown in Table V.

Figure 11. Photostress Evaluation, Box Beam Number 1.
View Showing Isochromatics Around Structural Door

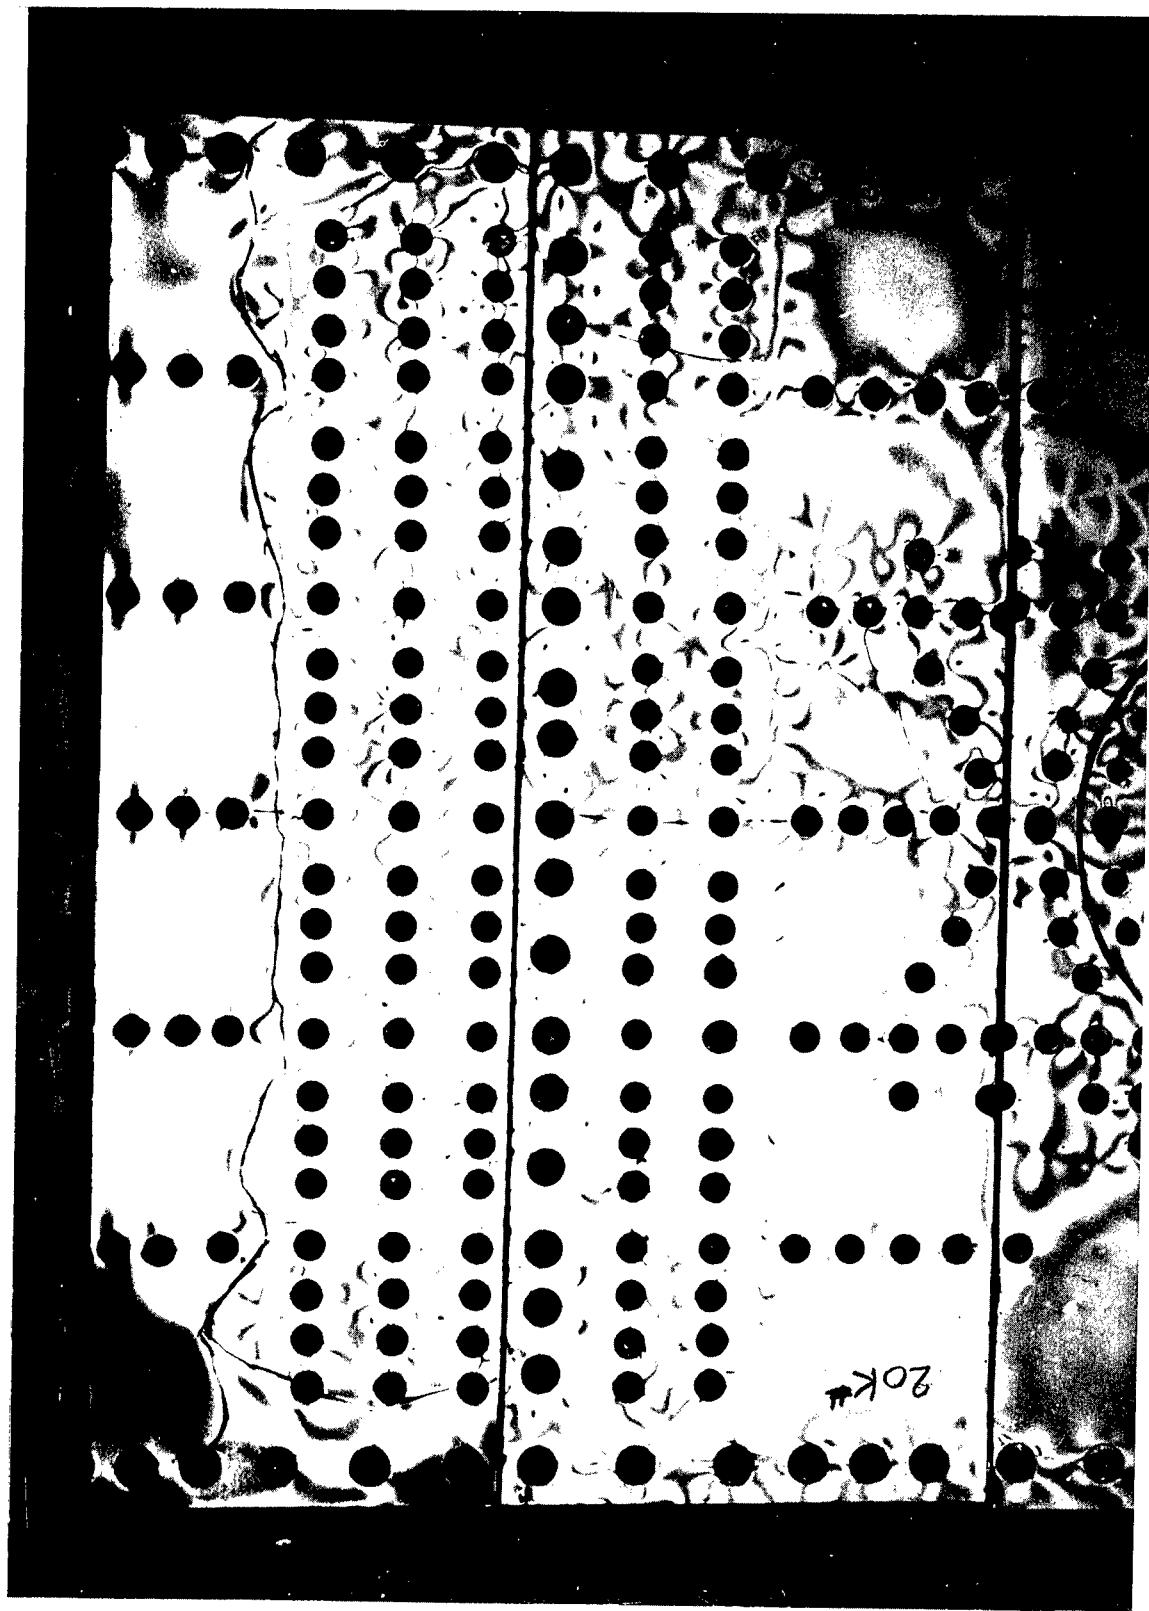
Figure 12. Photostress Evaluation, Box Beam Number 1.
View Showing Isochromatics Around Centerline Splice

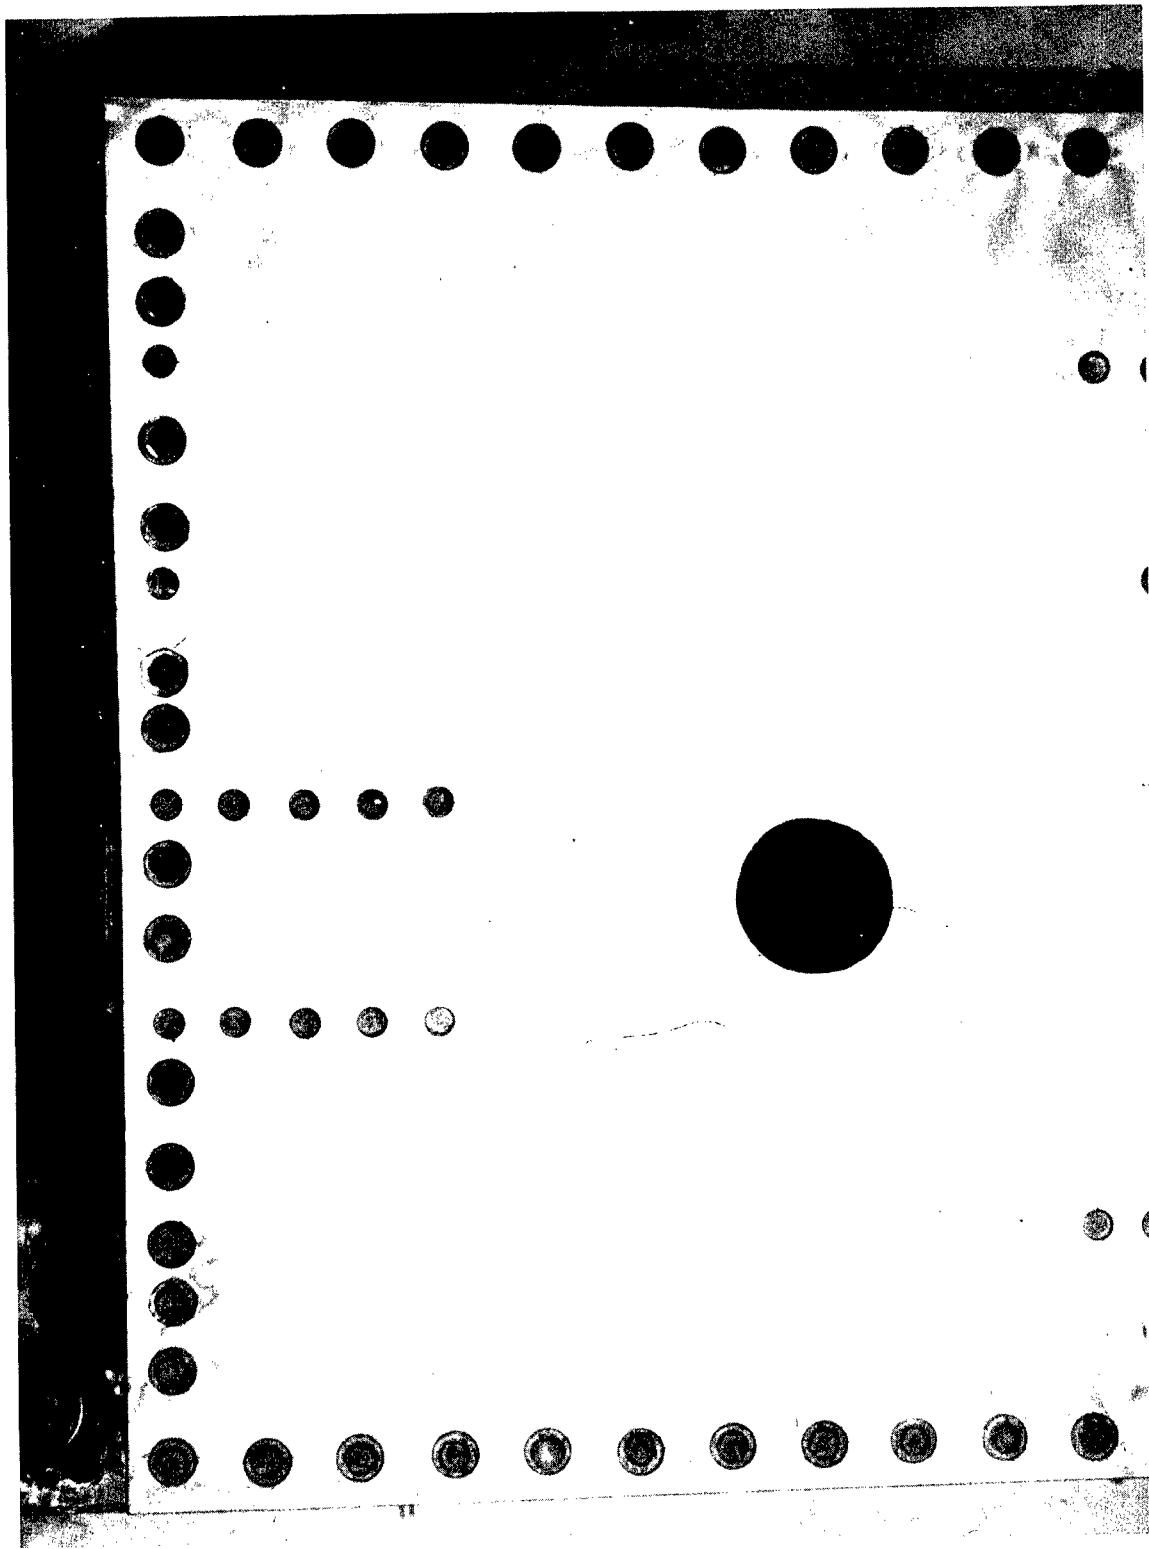
Figure 13. Photostress Evaluation, Box Beam Number 1.
View Showing Isochromatics Around Circular Cut-out

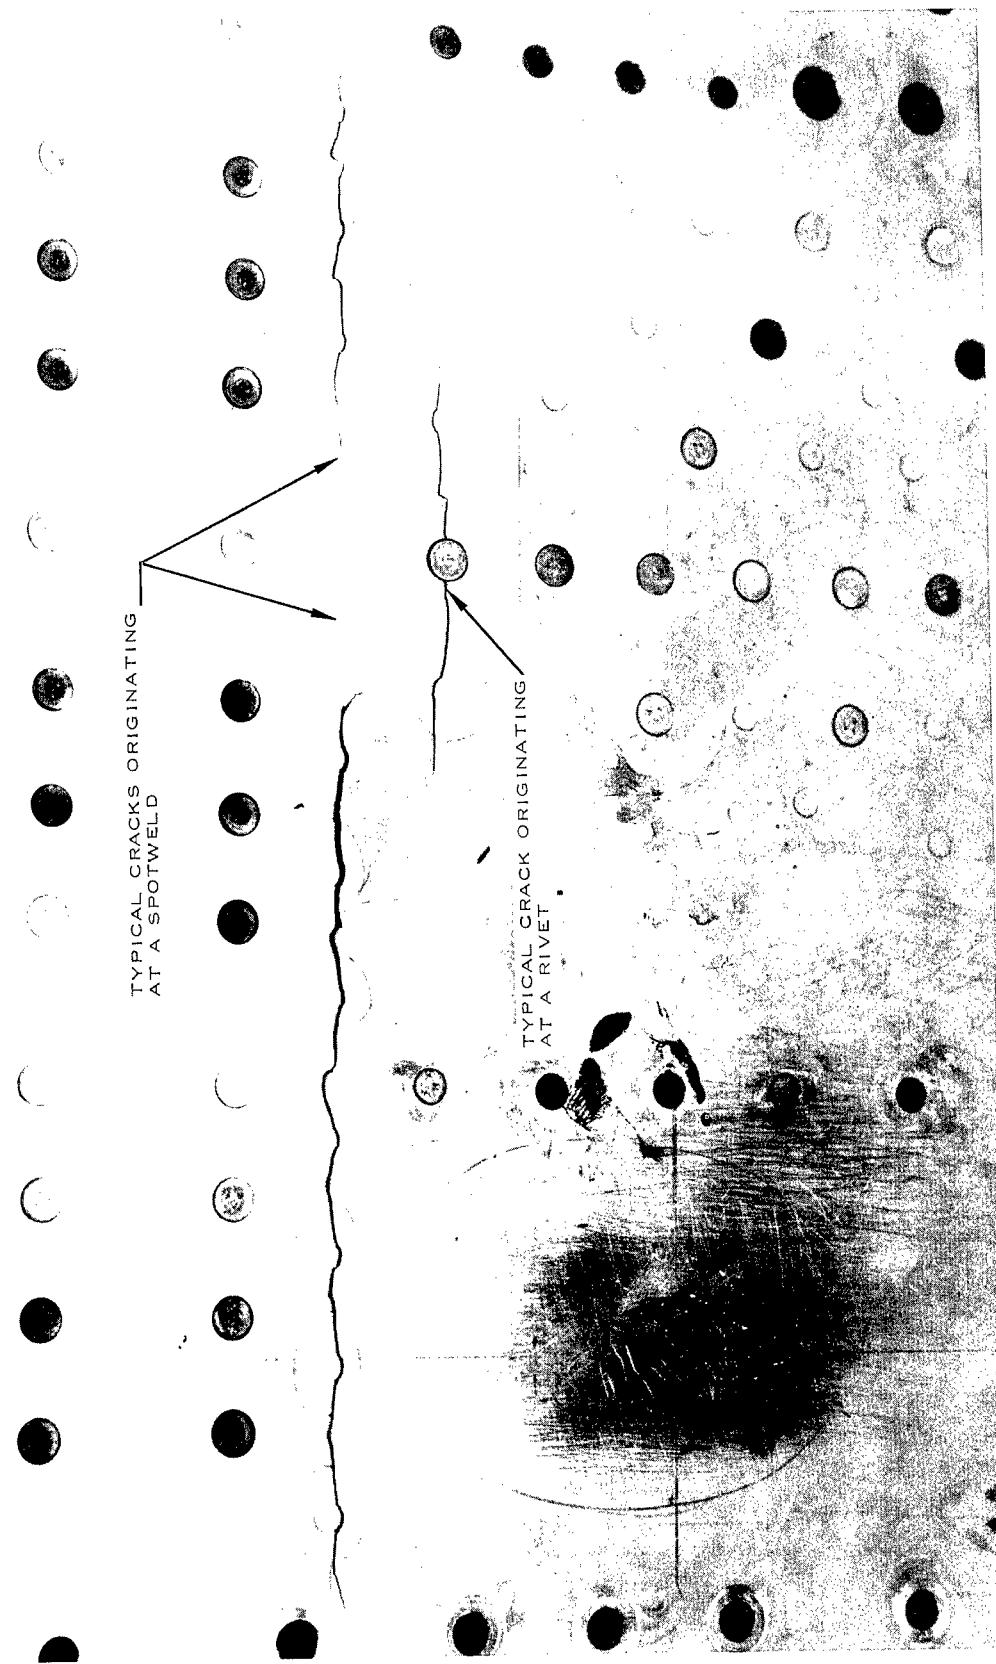
Description of Failures. - In all specimens (with the exception of number 1) the presence of widespread fatigue cracking was confined to the critical design areas: i.e. the center splice, the structural door, and the circular cutout. The critical sections of the test section listed in the order of relative severity are (1) the end attachments in the large structural door doubler, (2) the first row of attachments between the skin and bearing doubler at the centerline splice and, (3) the ends of the doubler reinforcing the small circular cutout. All fatigue cracks were confined to the skin only and, in addition, were usually found in the vicinity of loaded attachments. Of 201 observed fatigue cracks only 6 were found adjacent to non-loaded attachments. Figure 16 shows typical fatigue cracks in the vicinity of spotwelds and rivets.

Figure 16. Photo Showing Typical Cracks Around Rivets and Spotwelds. Number 4 Test Skin

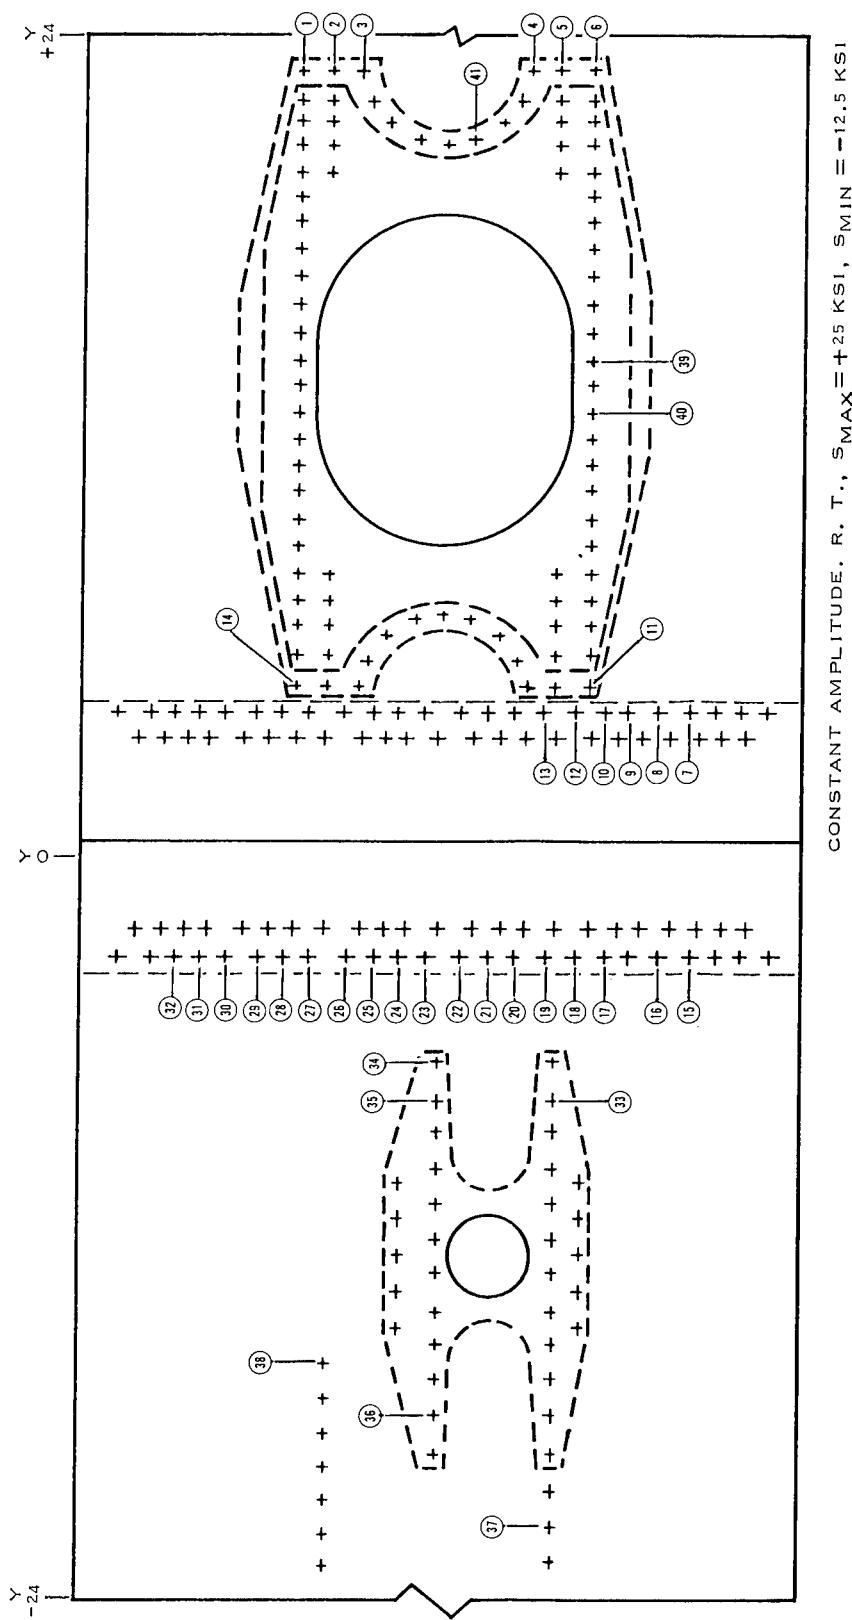
Specimen number 2 was tested at room temperature under GAG loads, $S_{max} = 25$ ksi and $S_{min} = -12.5$ ksi. Cracks were not observed in this specimen until after 31 344 cycles of load had been applied. At this time a total of 38 cracks were recorded. The lengths of these cracks varied from 0.10 inch to 1.37 inch. From the length of some of these cracks, it was apparent that they had been present for a considerable time without being detected during normal inspections. After the completion of 33 345 loading cycles some of the cracks had grown to a length sufficient to warrant discontinuation of the test.

A copy of the inspection log for this specimen is shown in Table VII and Figure 17 shows the location of the fatigue cracks observed during the test. Crack propagation curves are shown in Figure 24.

Figure 17. Fatigue Crack Location in Spotweld Test Specimen Number 2

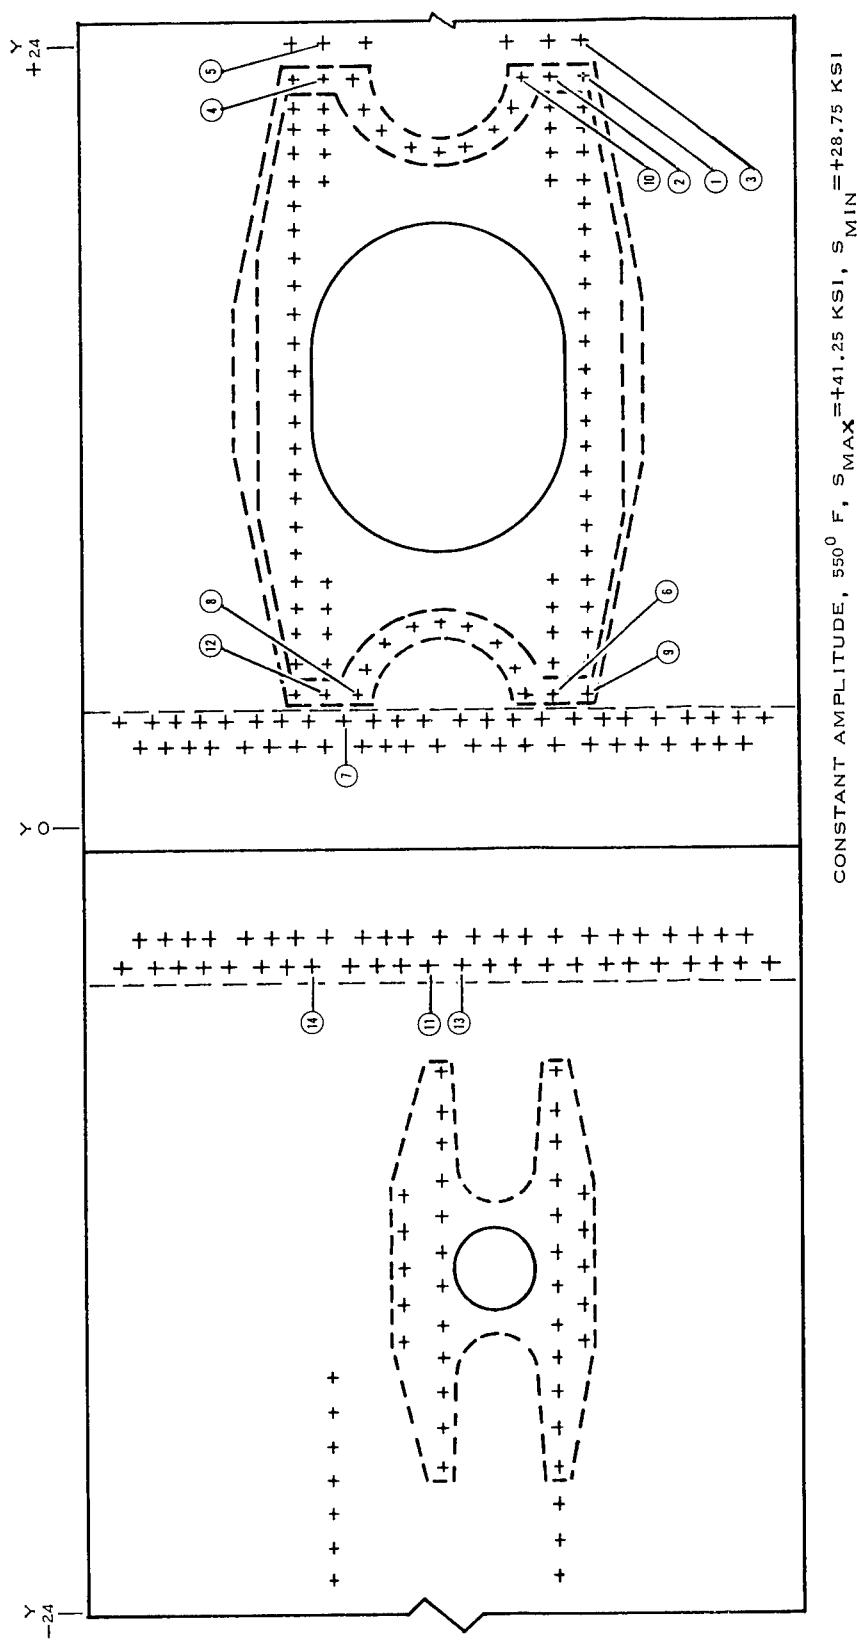
This specimen was tested under constant amplitude loading at 550°F with $S_{max} = 41.25$ ksi and $S_{min} = 28.75$ ksi. A crack length of 0.03 inches was reached after 49 400 cycles of load and a length of 0.50 inch was reached after 80 750 cycles. Testing was discontinued after a total of 159 955 cycles at which time the specimen contained a total of 12 actual fatigue cracks and 2 potential fatigue crack nuclei.

A copy of the inspection log is presented as Table VIII. The locations of all fatigue cracks are shown in Figure 18 while crack propagation curves for selected cracks are shown in Figure 25.

Figure 18. Fatigue Crack Locations in Spotwelded Test Specimen Number 3

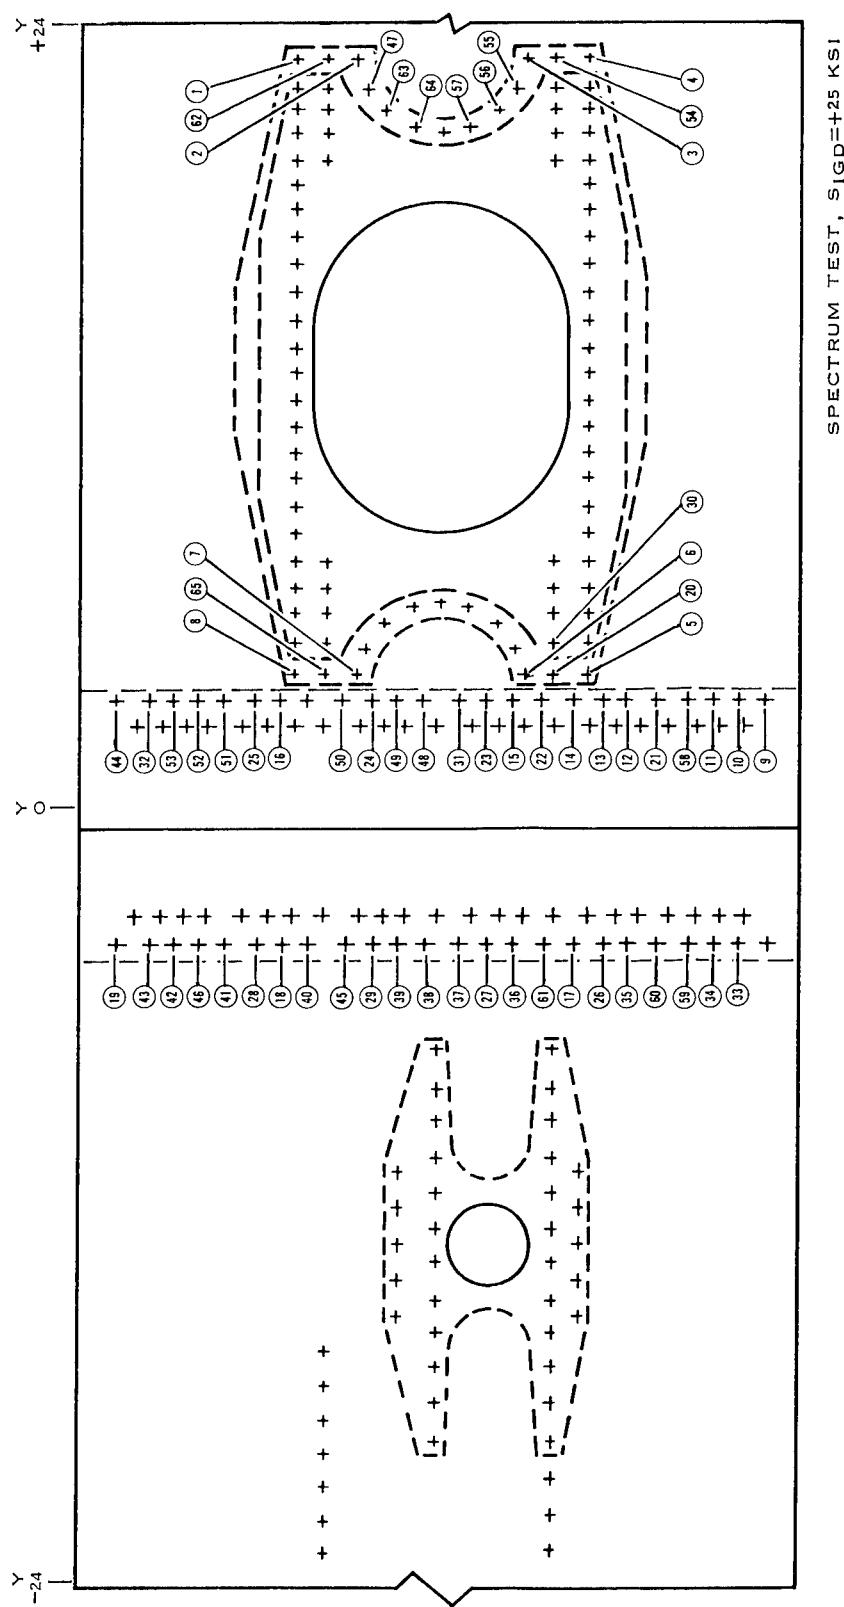
the specimen prominent areas of strain deformation were observed adjacent to 19 spotwelds in the door doubler and centerline splice areas of the test section. These incipient crack locations were logged and the test was continued. Upon completion of 1250 flights, cracks up to 0.60 inch long were observed in the majority of those areas which showed initial strain markings. Upon completion of 2500 flights cracking was sufficiently widespread to stop testing. At this time 64 cracks with lengths up to 6.0 inches had been logged. Table IX shows the inspection log for this test, Figure 19 locates all cracks and Figure 26 presents propagation data for selected cracks in critical areas.

Figure 19. Fatigue Crack Locations in Spotwelded Test Specimen Number 4

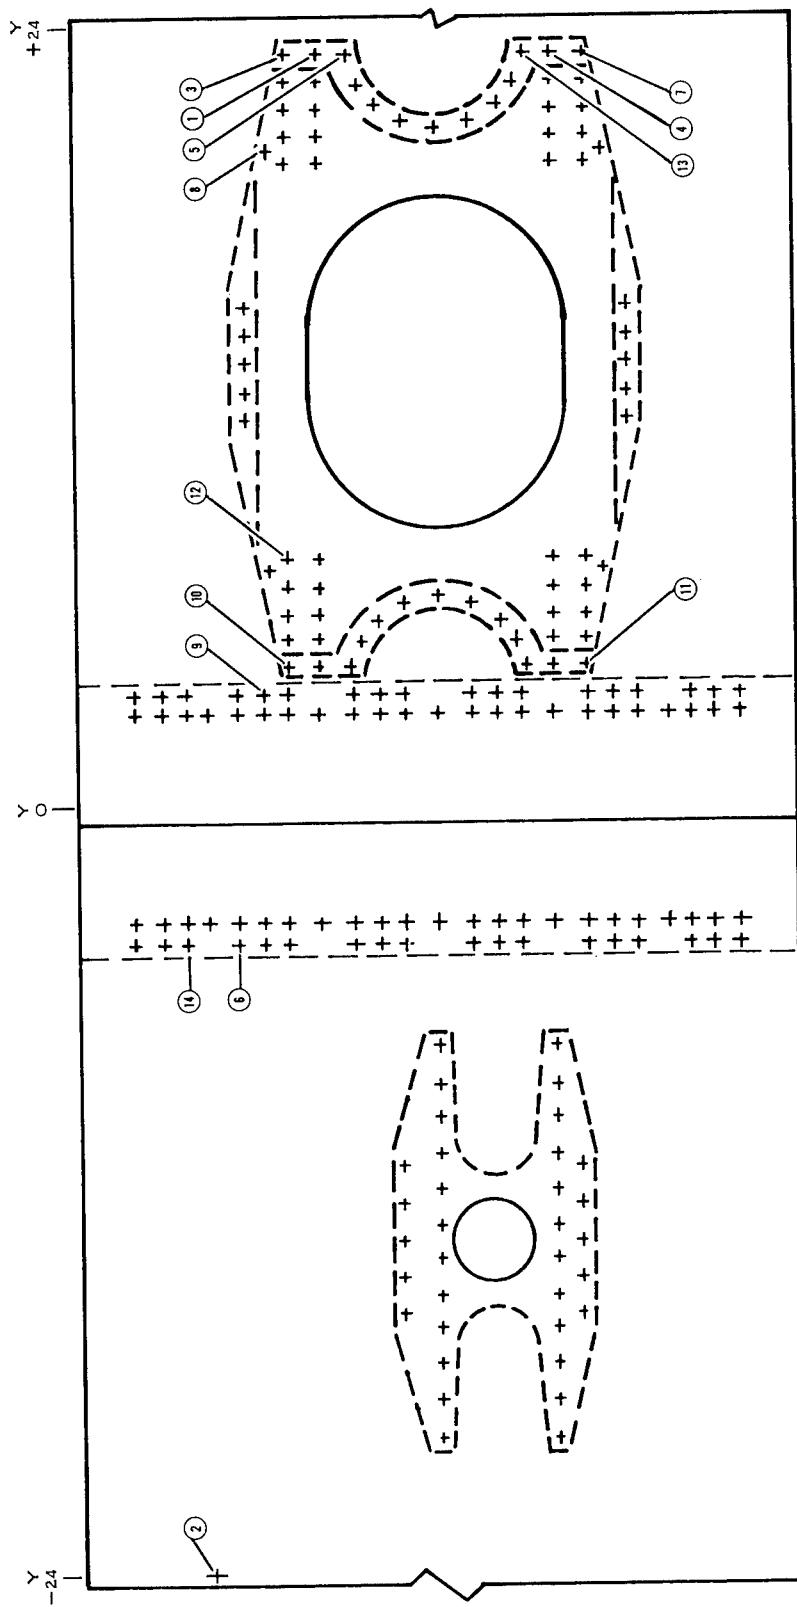
This specimen was tested at room temperature under GAG loading with $S_{max} = 25$ ksi and $S_{min} = -12.5$ ksi. Initial cracking was observed after 8450 cycles of load. A crack length of 0.50 inch was attained upon completion of 24 000 cycles. Testing was stopped after 48 301 load cycles had been applied to the specimen at which time 14 cracks had been observed in the test section. At this time the total crack length in the critical section of the specimen was approximately 14 inches which represents 30 percent of the total tension area.

Table X shows the inspection log for this specimen, and Figures 20 and 27 show the location of fatigue cracks and crack propagation information obtained from this test.

Figure 20. Fatigue Crack Locations in Riveted Test Specimen Number 5

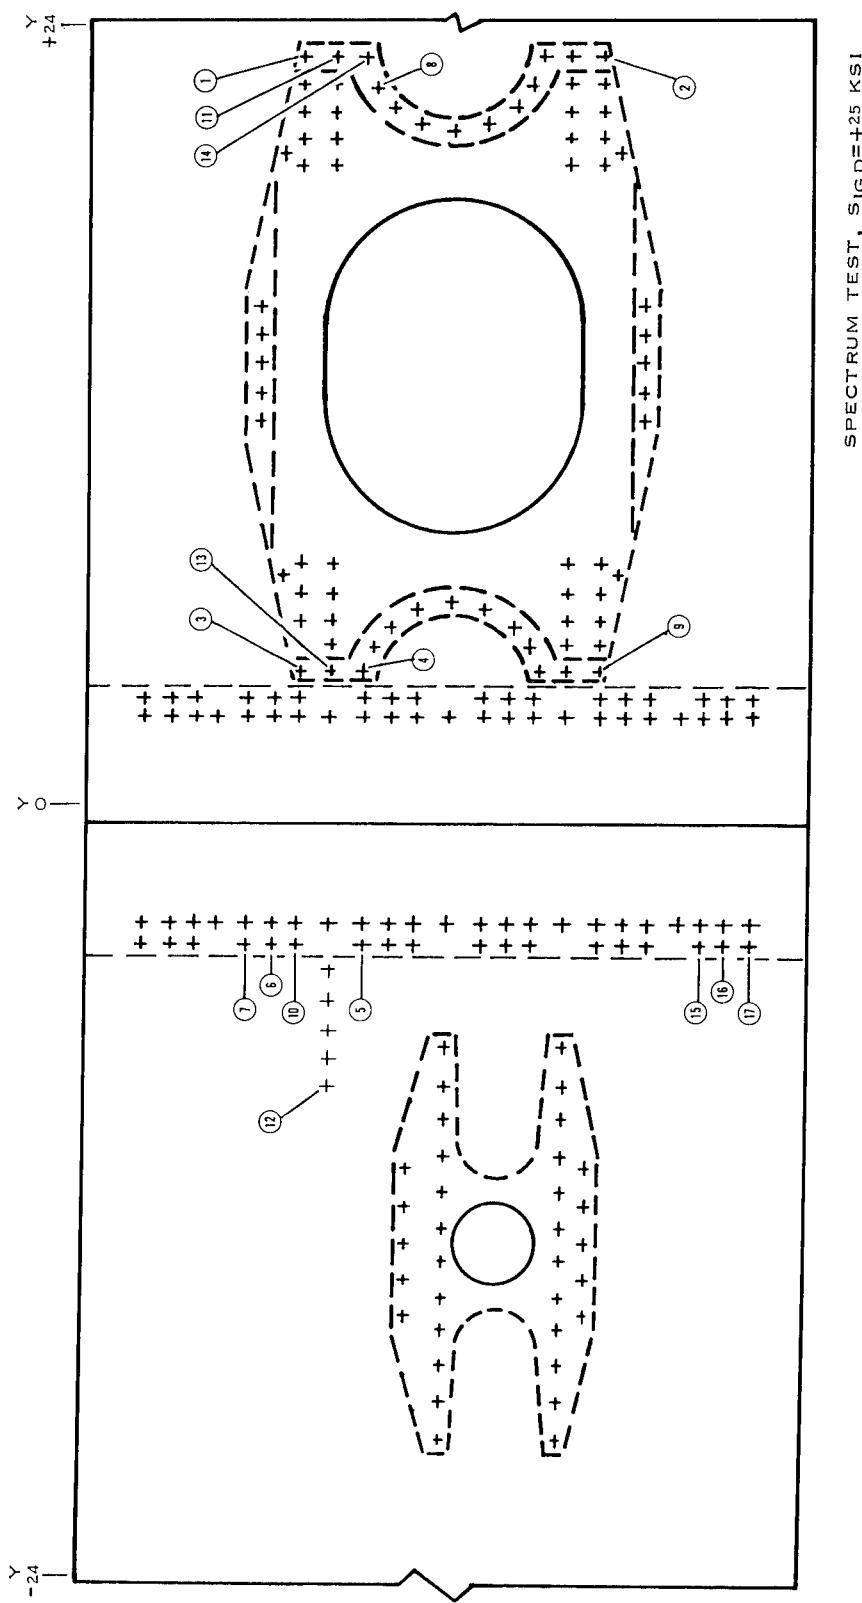
5600 flights. Upon completion of 6815 simulated flights a crack had grown to a length of 0.50 inch. Cycling was continued until 12 500 flights had been completed at which time the test was stopped. At this time, the specimen contained a total of 17 cracks with lengths varying up to approximately 3.50 inches.

The inspection log for this specimen is shown in Table XI, crack locations and crack propagation curves are presented in Figures 21 and 28 respectively.

Figure 21. Fatigue Crack Locations in Riveted Test Specimen Number 6

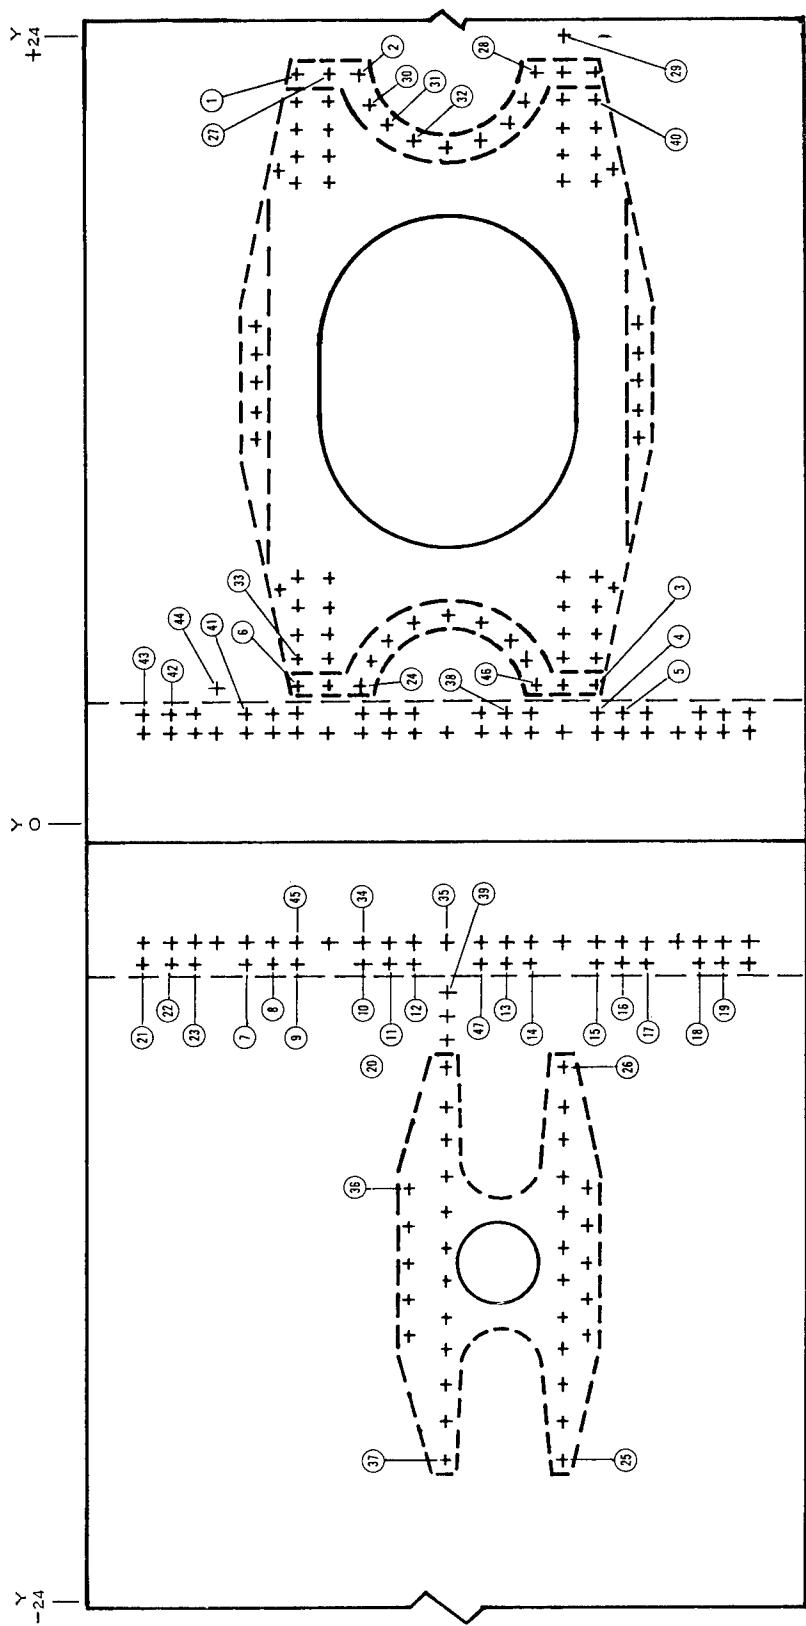
This specimen was tested under constant amplitude conditions at 550°F, $S_{max} = 41.25$ ksi and $S_{min} = 28.75$ ksi. Initial cracking ($l_c = 0.03$) was observed in the test skin at the end of the door doubler following the application of 41 700 load cycles. This crack had grown to a length of 0.50 inch after 99 000 cycles. Testing was terminated after 154 047 cycles at which time the specimen contained 47 cracks with lengths ranging up to approximately 3.0 inches.

The inspection log for this specimen is shown in Table XII, crack locations and crack propagation curves are shown in Figures 22 and 29 respectively.

Figure 22. Fatigue Crack Locations in Riveted Test Specimen Number 7

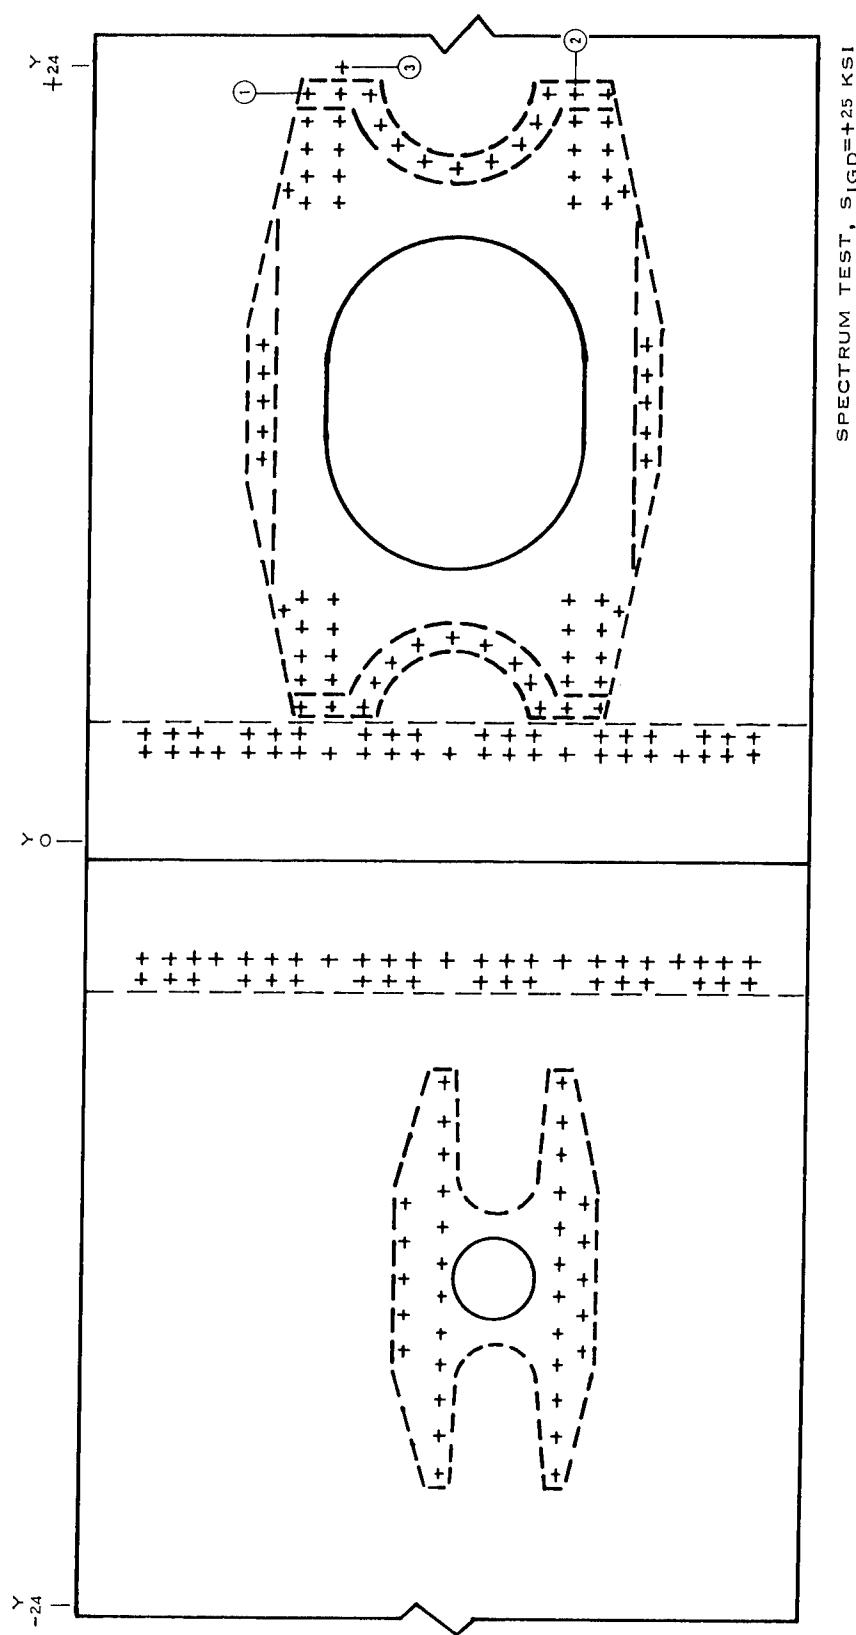
The number 8 specimen was tested under spectrum loading conditions with $S_{lg_D} = 25$ ksi. At the completion of 9500 simulated flights a crack length of 0.03 inch was reached. The test was continued until 12 500 flights had been applied. At this time the specimen contained 3 small cracks in the test section with a maximum observed length of 0.10 inch.

The inspection log for this specimen is shown in Table XIII and Figure 23 is a sketch showing the location of the observed cracks. Crack propagation curves for this specimen are presented in Figure 30.

Figure 23. Fatigue Crack Locations in Riveted Test Specimen Number 8
